Give Roof LEAKS the "Boot"...

Roof LEAKS Happen in a "Flash"...

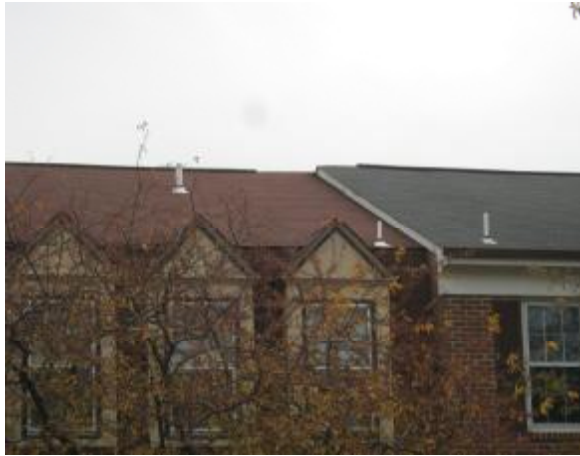
Every, I mean every home has at least one opening in the roof system. In the photo on the left we can see them from the street level on the roofs of townhouses.

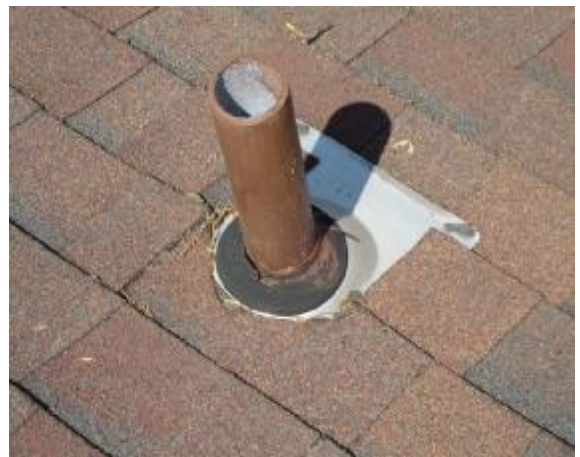
The one shown [below] here is called a plumbing vent stack "*boot*" and serves as a waterproofing transition device for a vent pipe that comes up through the roof deck, through the shingled surface and into the air. There are many different styles made of a variety of materials. The goal with the inspection is to look for decayed, askew or even missing items that keep rain water out of the attic. In this picture, the rubber has decayed and allows water to seep into the attic, onto the attic insulation and eventually showing as a water stain on ceiling drywall.

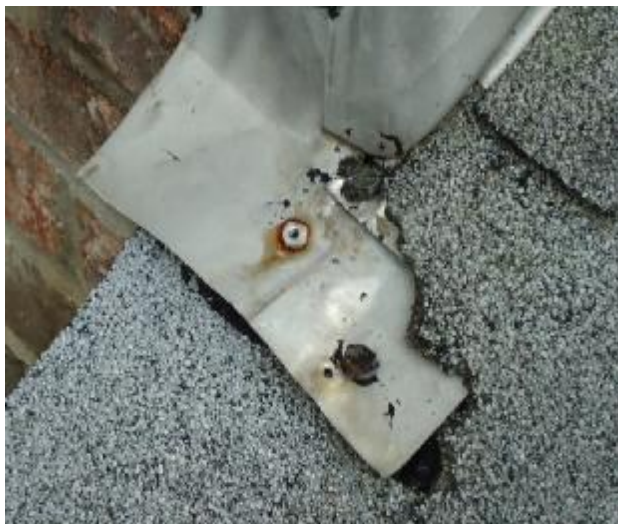
Another area at the roofing system surface that is often a problem is found at "*flashing*", and is commonly found at a chimney. Again, there are a variety of methods and materials used to transition from masonry to in this case asphalt shingles. Leaks develop where improper flashing, deteriorated materials and unprofessional repairs are present. Look for clean, neat, and screw or nail free methods of attachment or fastening. At the right, the photo shows an attempt to attach a section of aluminum from the masonry brick to the asphalt shingled surface. This not an effective method of repair, and creates more opportunities for water intrusion and slow but sure damage.
